SEMI-RIGID OR NON-RIGID STRUCTURES  
FOR RE-ENTRY APPLICATIONS

Space-General, a Division of  
Aerojet-General Corporation

FINAL TECHNICAL REPORT AFML-TR-67-310

Part 2 Fabrication and Test

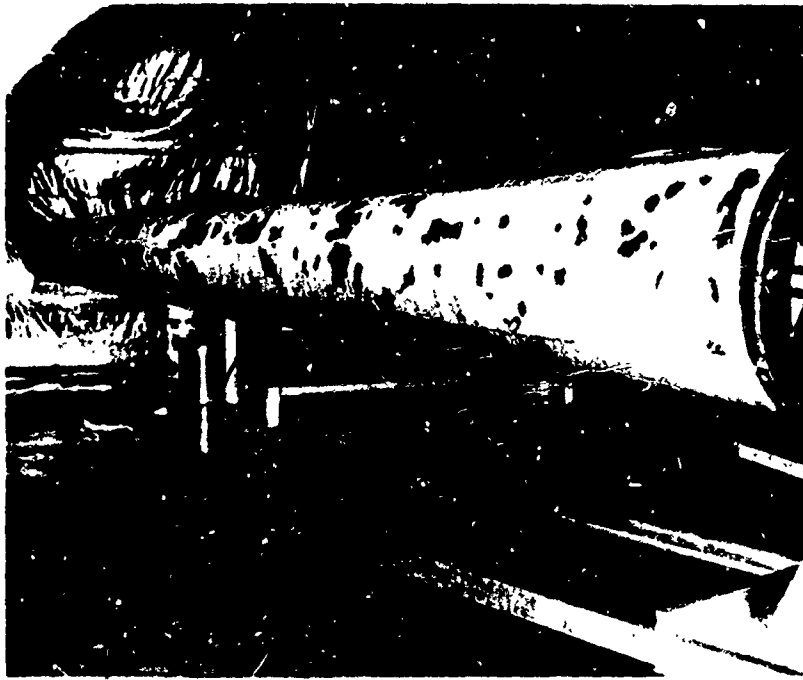
Figure 158. Boom with Portions of Outer Silicone Rubber Coating Removed to Expose Damage that Occurred During First Pre-Cure Operation

A fresh batch of 0.125-inch-thick calender S-6510 was obtained to re-coat the boom using additional RTV 655 painted on the area as an adhesive. The cuff areas were again shrink-taped to hold down the fabric edges and the tape was shrunk using the heat gun shown in Figure 160. This photograph also shows the thermocouple wires which passed between the impregnated metal fabric and the outer silicone rubber coating. The thermocouple junctions were spot welded to the outer surface of the metal fabric before impregnation.

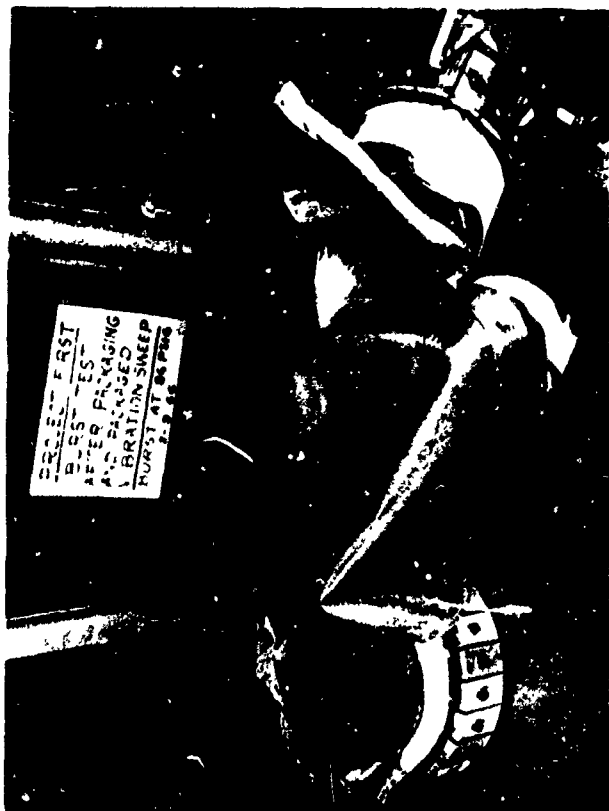
After the above testing, the specimen was burst-tested with no external loads except the loading jig counterweight of 22.0 lb. The internal pressure was increased at a rate of approximately 2 psi per second. At 60 psig, a blister began to form in the S-6510 coating. Between 60 and 75 psig the pressure rise rate averaged 1 psi per second. At 75 psig the blister ruptured. Between 75 and 85

Figure 226. Frustum S/N 6 After Burst Test (Test 4)
